DOT/FAA/AR-02/121

Guidelines for Analysis, Testing, and Nondestructive Inspection of Impact- Damaged Composite Sandwich Structures

March 2003

Final Report

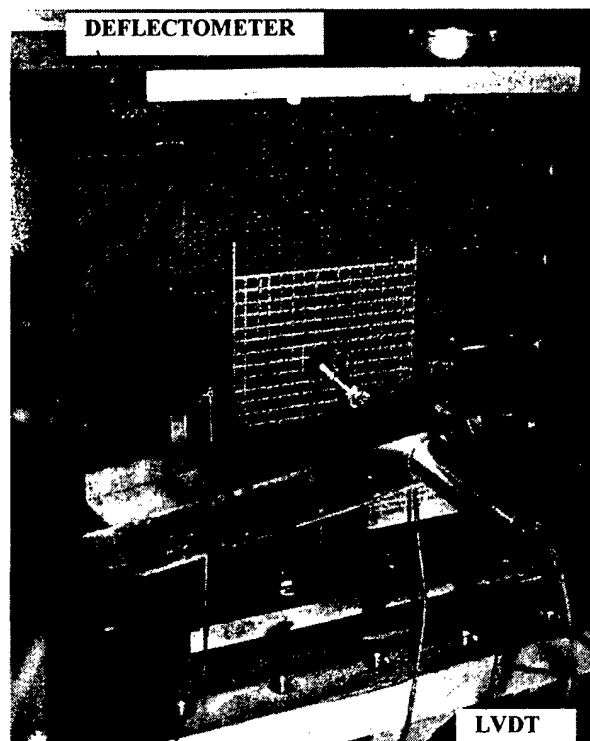
FIGURE 2-2. THE SANDWICH SPECIMEN IN THE TEST FIXTURE, LVDT, AND THE DEFLECTOMETER

The test fixturing and boundary conditions used in these investigations are reported in detail in references 3 and 6. The typical specimen geometry along with the locations of the strain gages and the location for the measurement of out-of-plane displacement is illustrated in figure 2-1. An additional strain gage was mounted at the center of the damage region to monitor the surface strains in the skin. A spring-loaded linear variable differential transformer (LVDT) was used to measure the out-of-plane displacement at aforementioned location. In addition, a deflectometer was used to measure the end-shortening of the specimen. The LVDT and deflectometer along with the specimen in the test fixture are illustrated in figure 2-2.

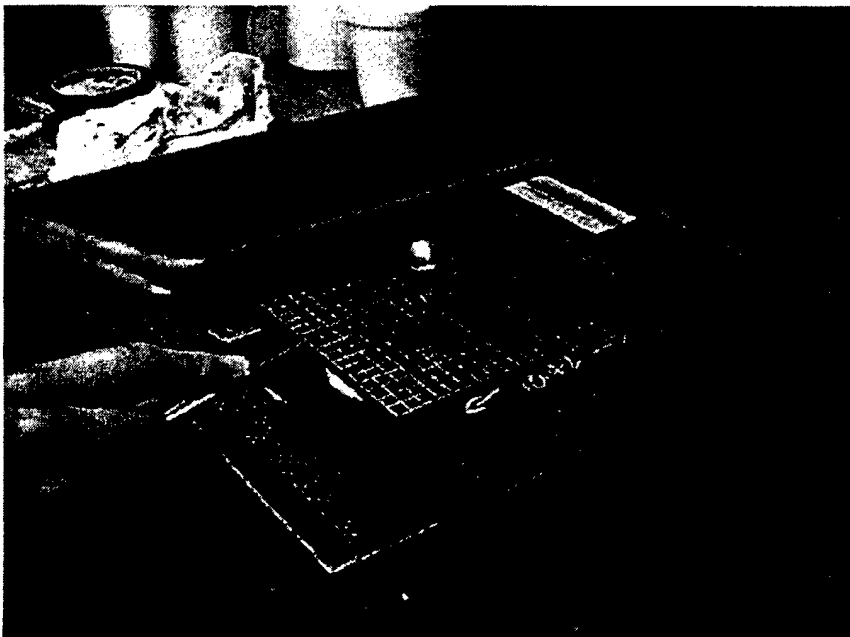
FIGURE 4-2. MANUAL IMPACT HAMMER (AIRBUS DESIGN)

In the acoustical tap testing, the characteristic resonant sound emanating from the tap test is analyzed by the human ear. The audible resonant sound will depend on the sandwich local impedance and tap mass/hammer characteristics. The damaged region is characterized by a dull (dead) sound, which can be attributed to the decreased participation of the higher frequency modes. The manual tap test hammer (Airbus design) is shown in figure 4-2.
